BREVARD SPECIAL EDITION

SR 528 / SR 3 EMERGENCY BRIDGE REPAIR

Submitted by: Hector Matos

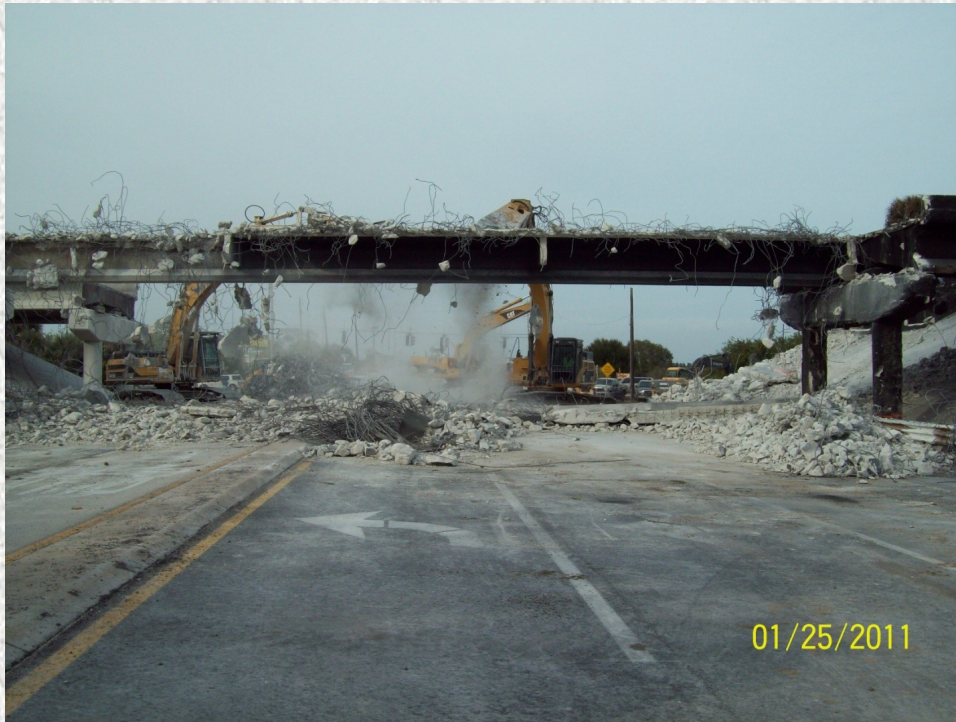
The bridges were demolished in two (2) days by the giant concrete eaters.

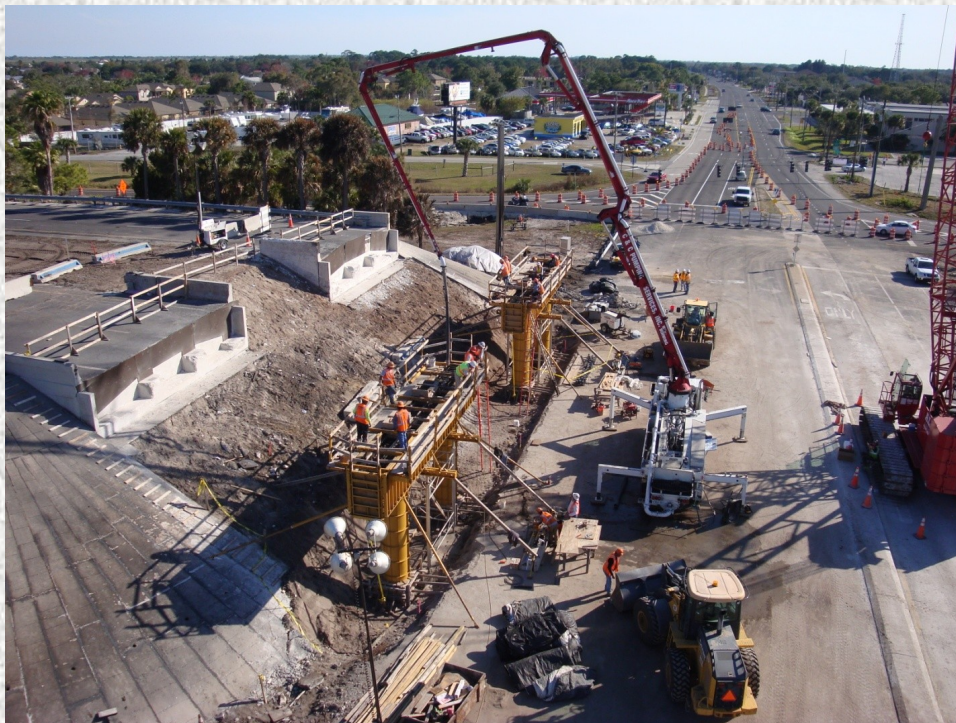
Monolithic concrete pour of the columns and pier caps. This type of pour saved the contractor three (3) days. The forming of the columns and pier caps was accomplished in four (4) days.

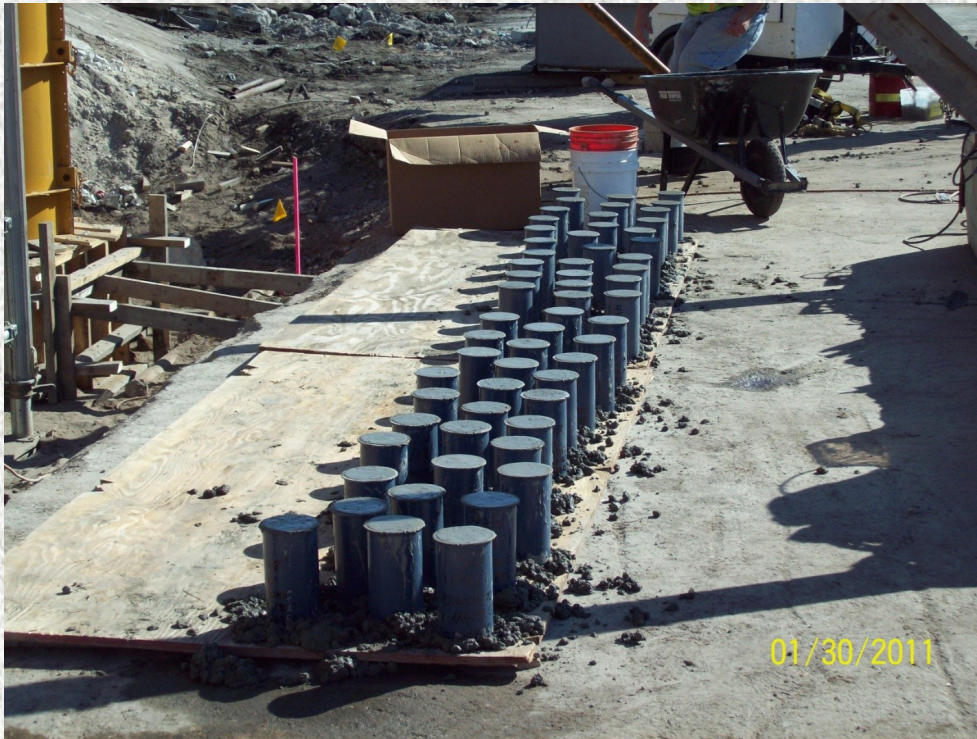
Not knowing how long the concrete was going to cure and achieve the design strength for the substructure pour, a total of 60 concrete cylinders were made.

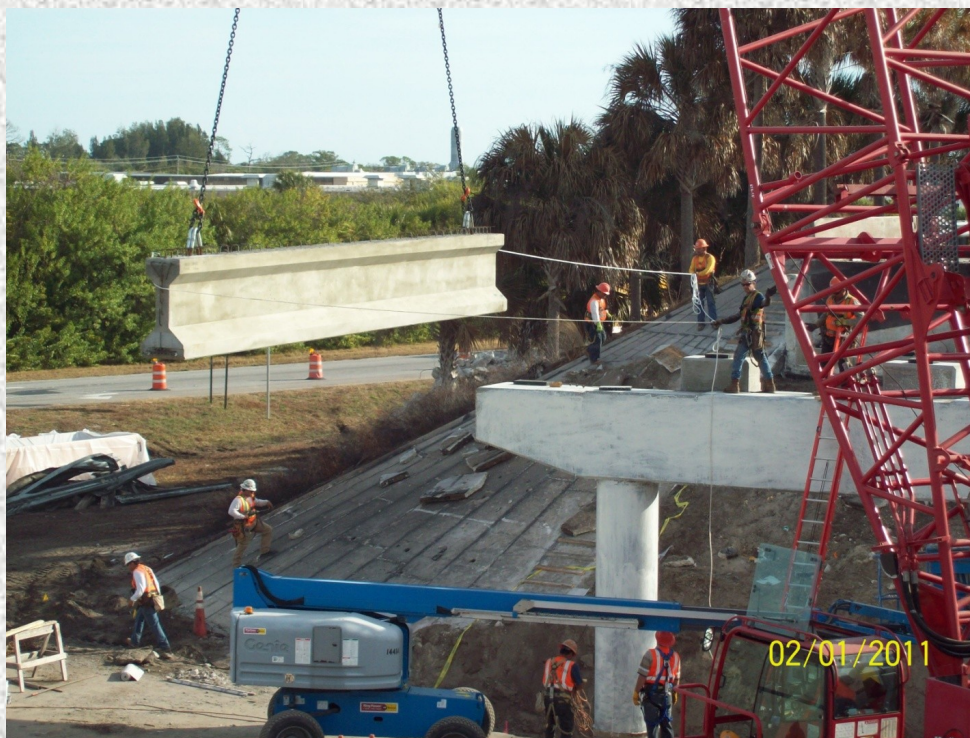
Two days after pouring the substructure, beams were being set. The contractor accomplished this in one day.

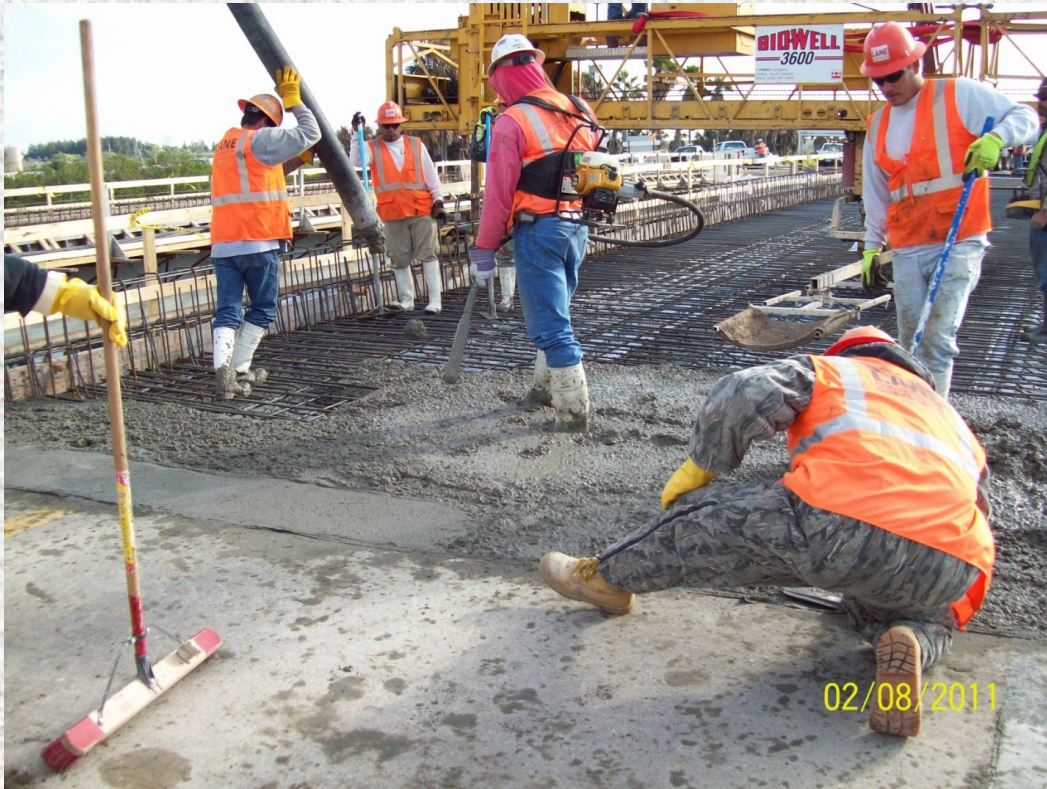
Seven days after the beams were set, the bridge decks were ready for concrete. The contractor used stay in place forms for the bridge decks.

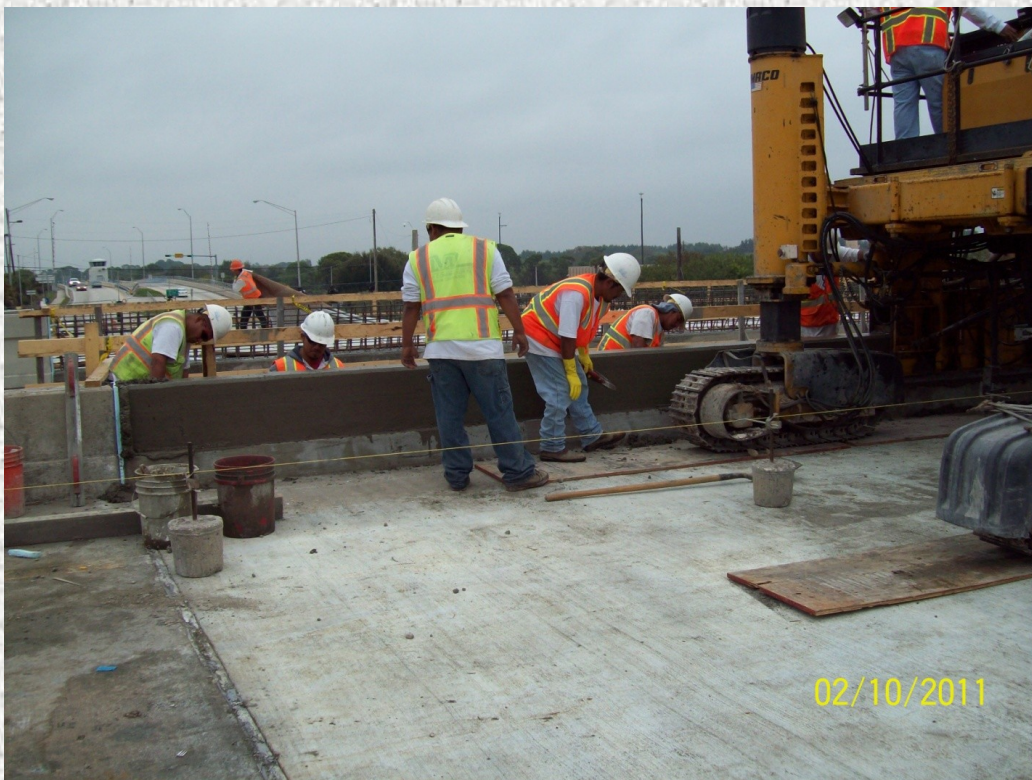
Two days after the decks were poured; the barrier walls were slip-formed.

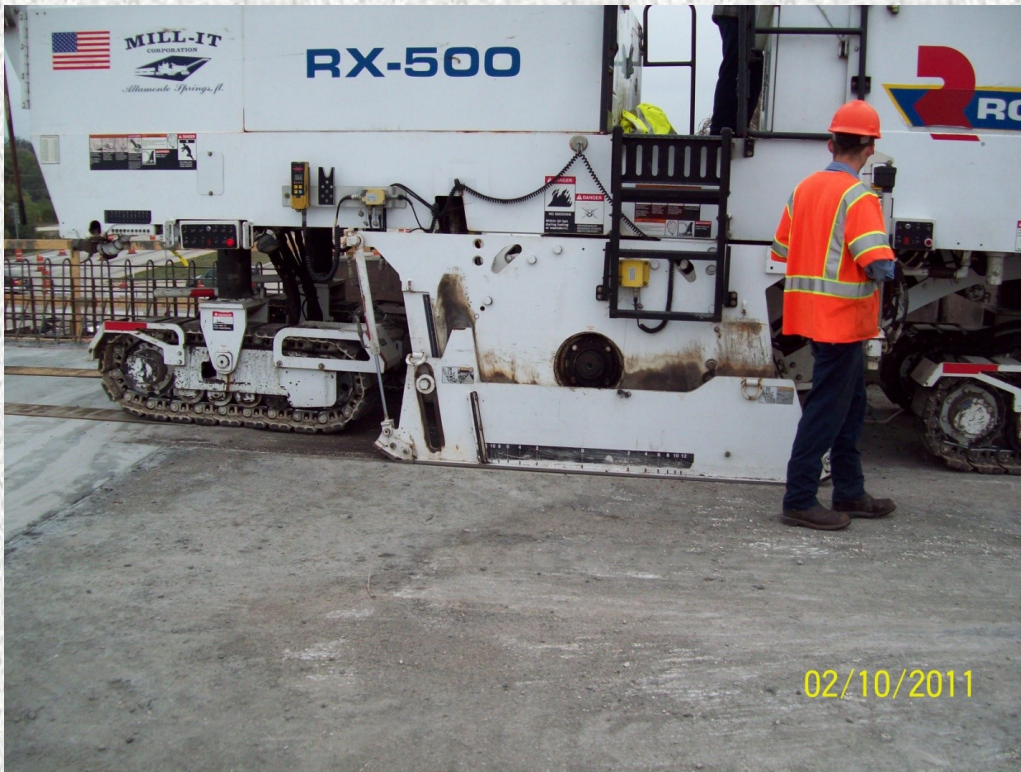
While the barrier walls were being placed, milling of the SR-528 pavement occurred.

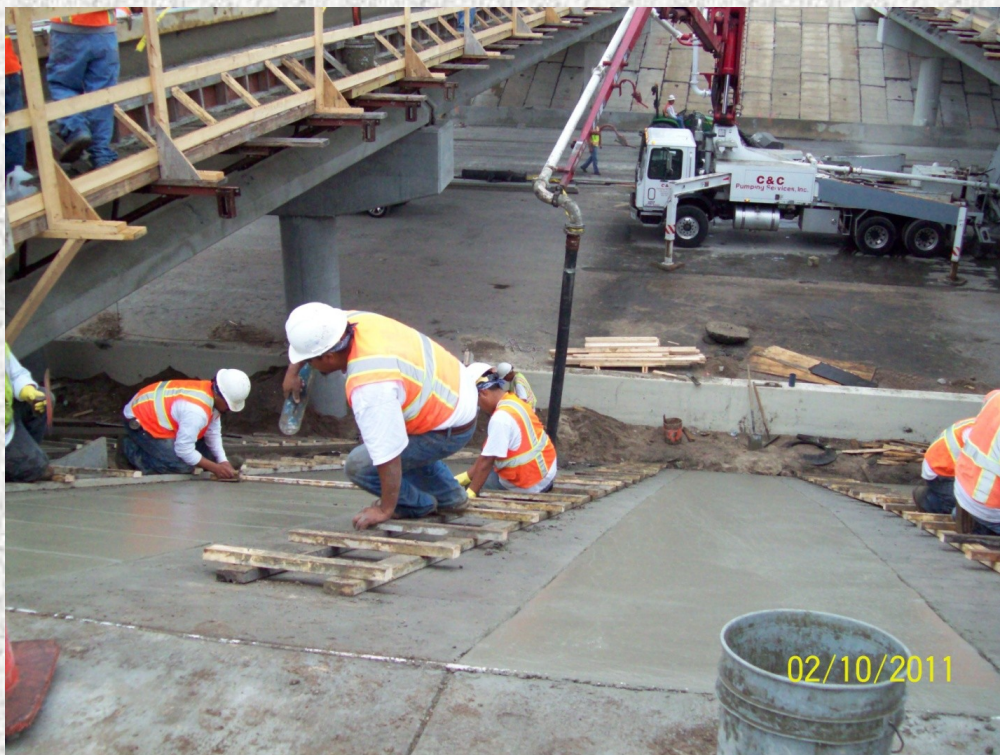
The concrete slopes were also being placed.

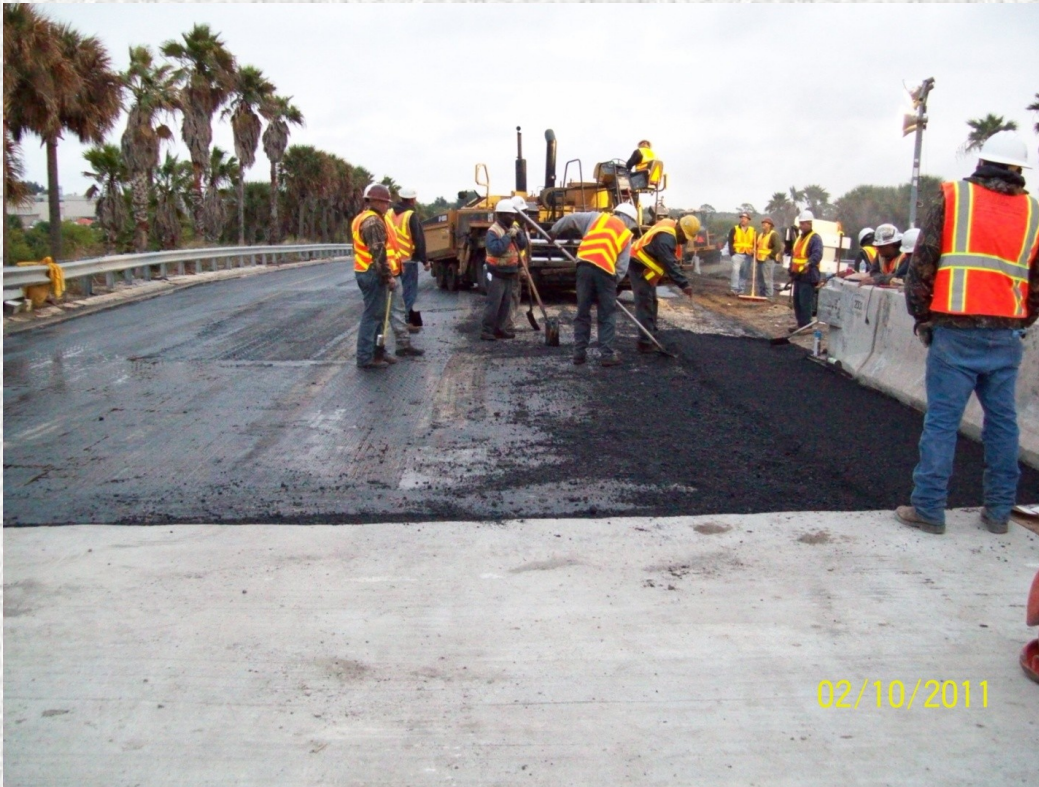
Once the milling was completed, paving of SR 528 began.

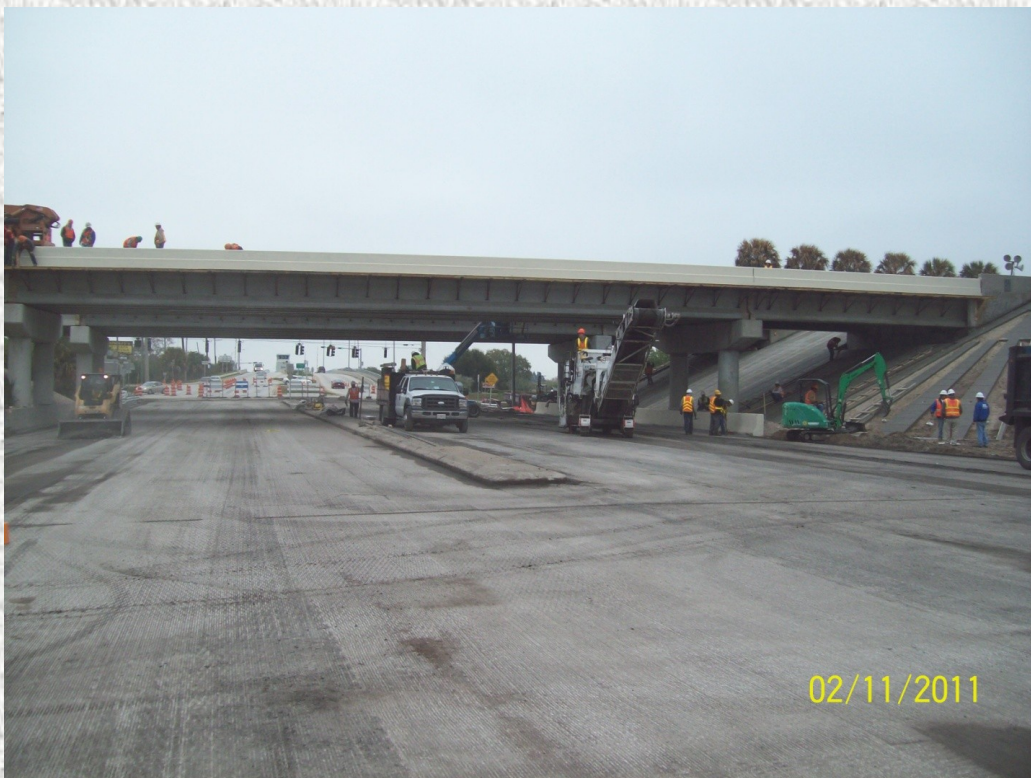
Milling of SR 3 was completed the next day.

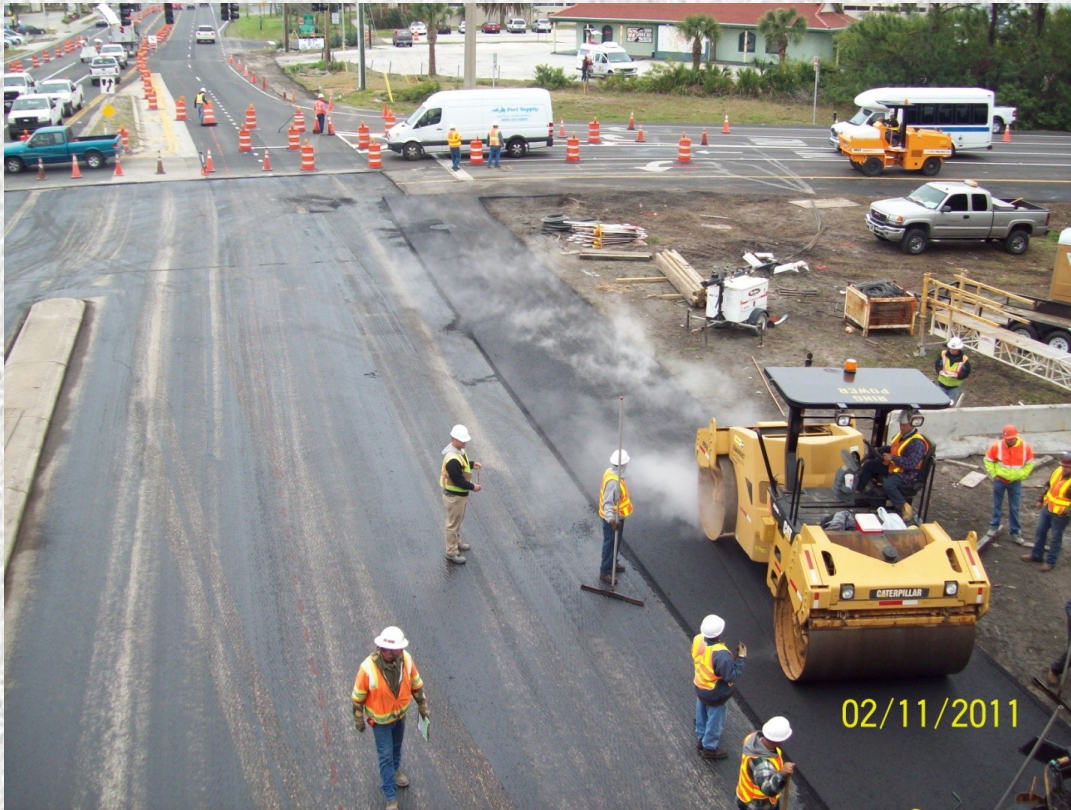
Once milled, SR 3 was paved.

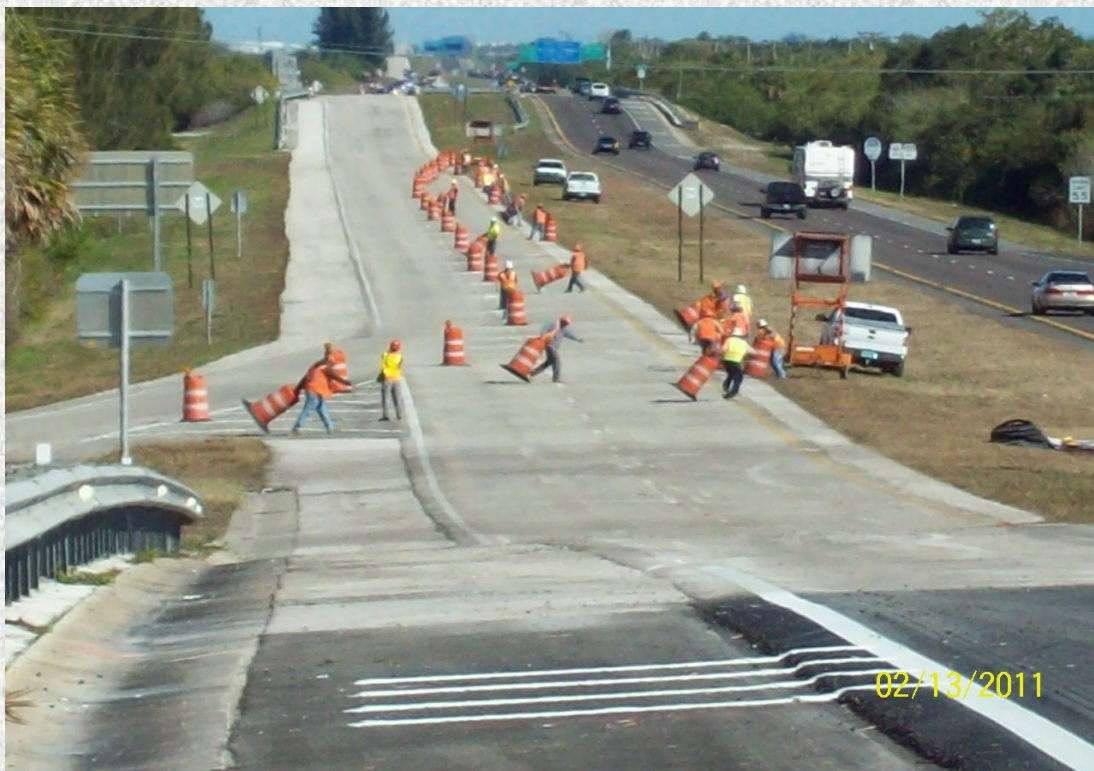
Two days later the barrels were removed to allow the traffic onto the bridges.

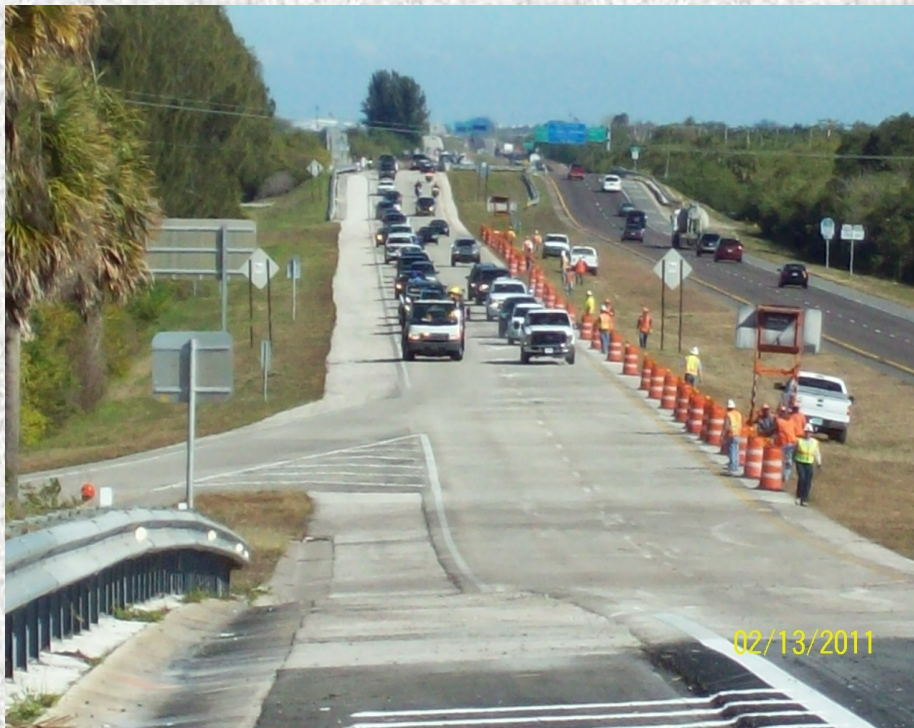
Traffic was allowed on the bridges on Sunday, February 13, 2011 at 2:30pm, three (3) days ahead of schedule. A slow roll was conducted in order to remove the barrels and bring the traffic onto the bridges.

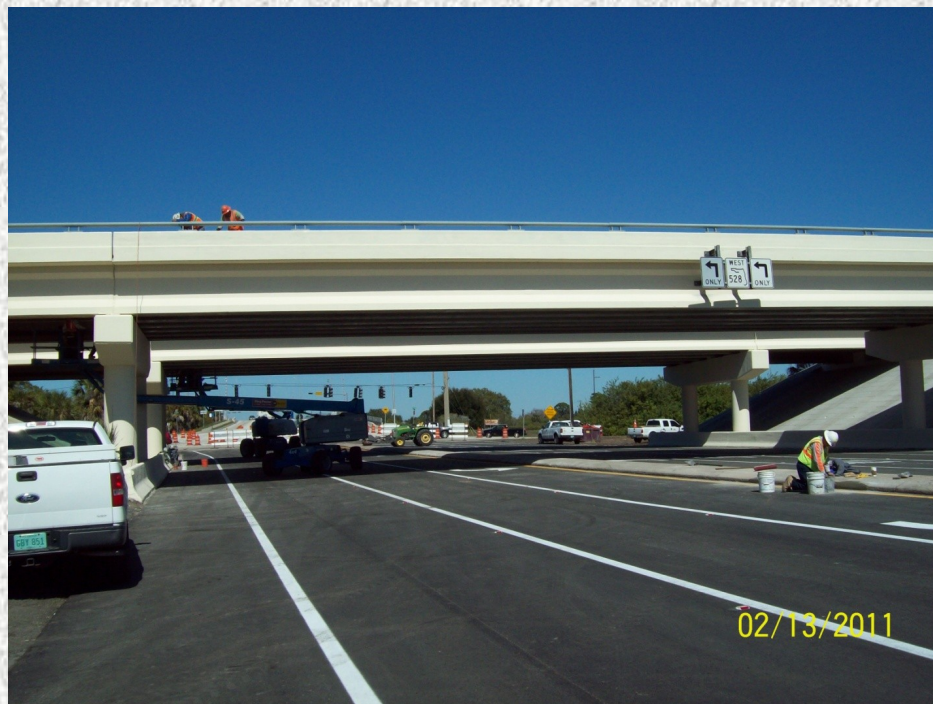
The completed bridges.
